CONTACTOR RELAY REPLACEMENT

Written for range models manufactured after 2019. The same process applies to all previous range models.

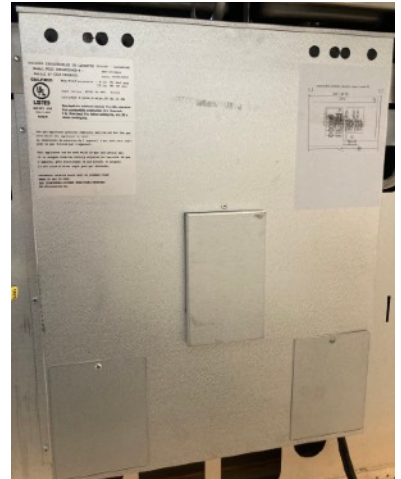
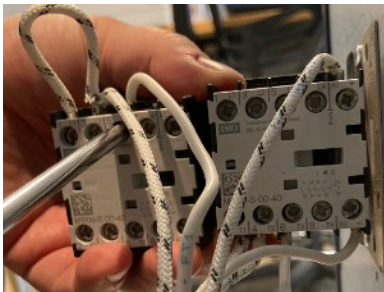
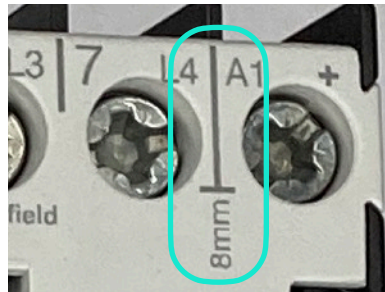
1. Pull the range away from the wall to access the rear of the unit. Take note of the range height and countertop gap on each side, and of any blocking methods to level the unit after removal.
2. Disconnect power to the range.
3. Remove the sheet metal panel cover on the back of unit to access and locate the faulty relay.
4. While the old relay is still mounted, undo one terminal at a time while swapping the wires to the corresponding terminal on the new relay. *(do not allow any of the wire sheathing to be clamped into the relay. Strip back or make sure only bare wiring is contacting the terminals to guarantee a positive connection. For reference: the depth of each terminal clamp is 8mm / 5/16".)* Also check to make sure each wire is tight and snug. Any loose connections can overheat and start a fire.

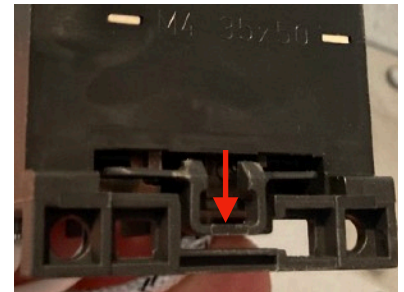
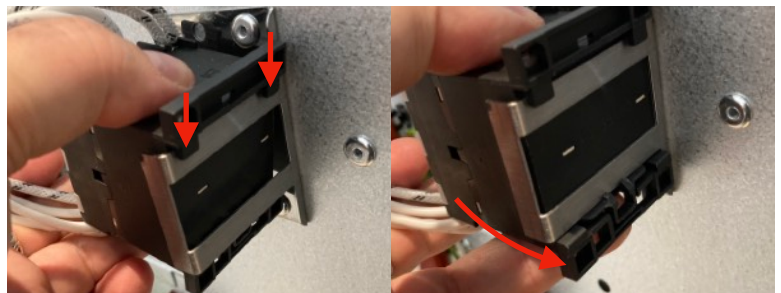
5. Once each wire has been moved to each new terminal and verified correct (see *Contacting Relay Wiring Reference .pdf* for the appropriate model date), press down on the bottom tab to unclip and remove the old contactor from the mounting bracket and discard. Now mount the new contactor onto the mounting bracket on the chassis (hook both tabs over the top edge of the bracket and swing the relay down to clip it under the bottom edge).
